Holding up the bank! An investigation of factors that affect streambank erosion

Natalie Lamagna
ES-245: Hydrology and Limnology

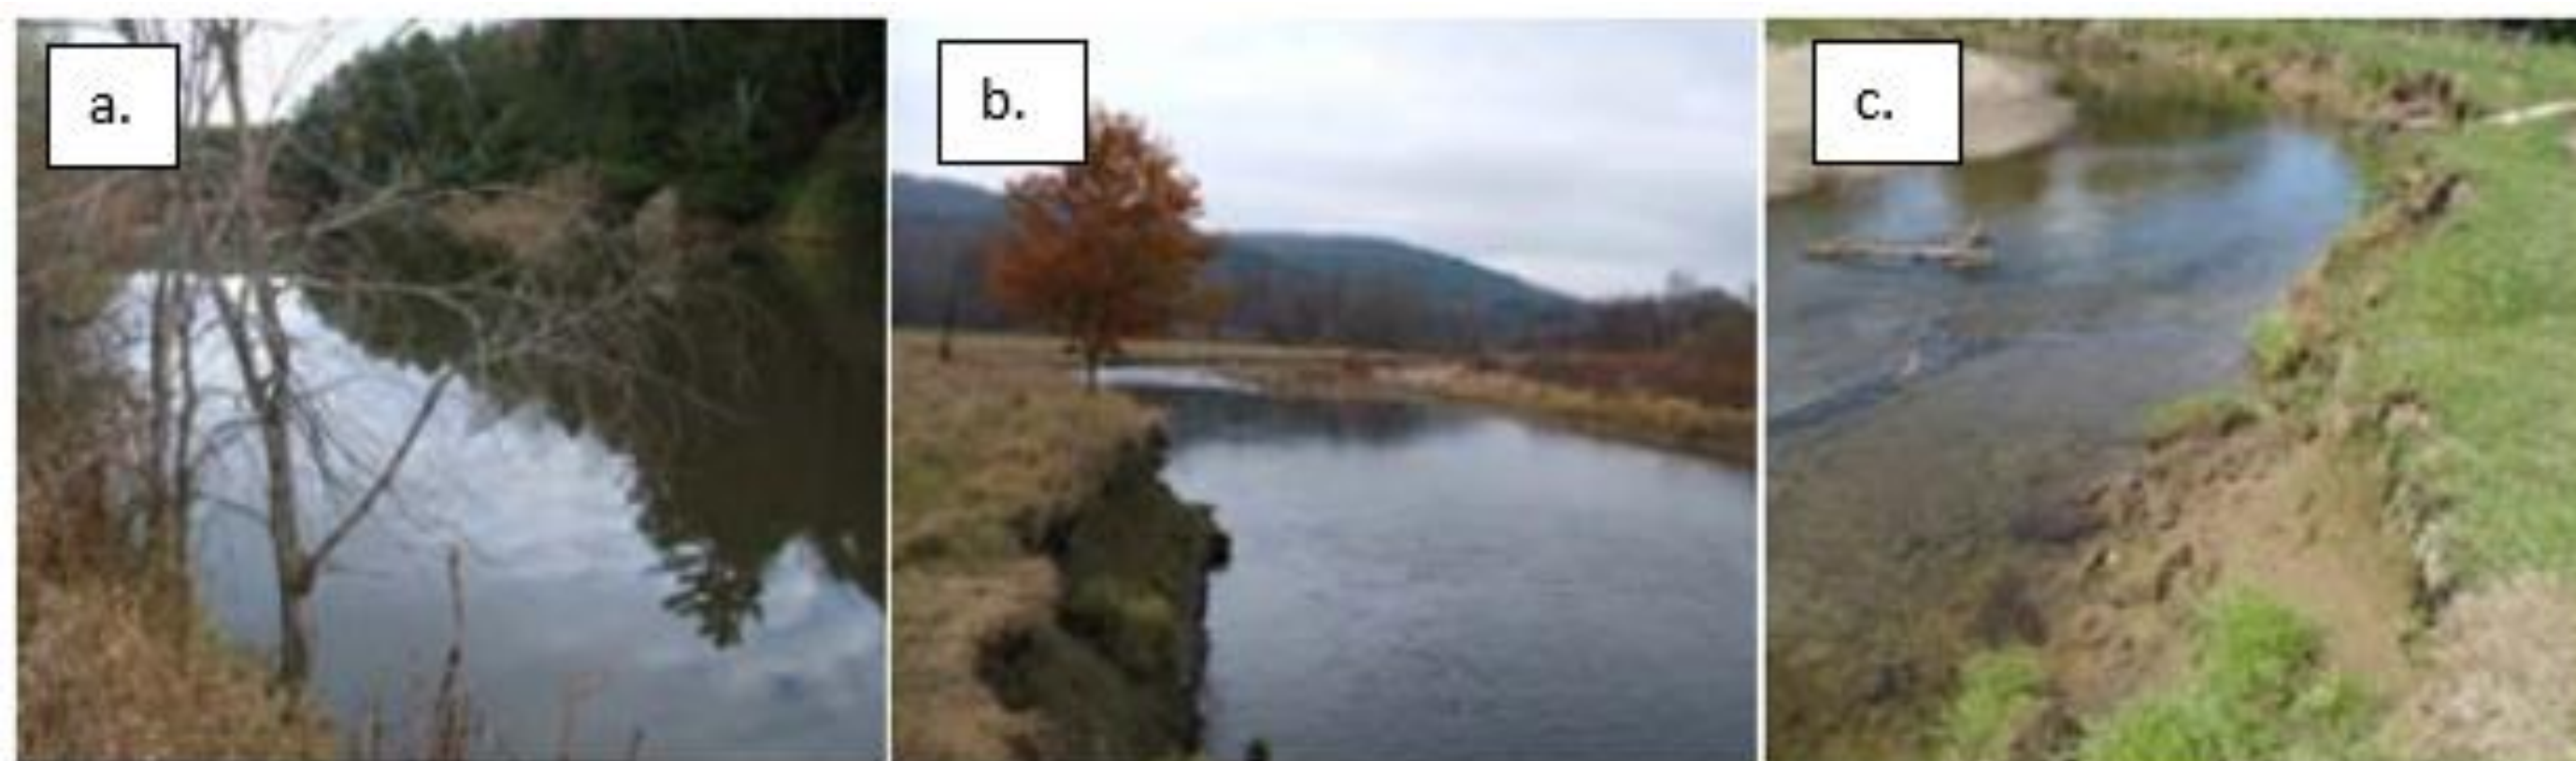
Figure 1: These images were taken by Simon et al. (2012) along the Missisquoi River. A streambank with minimal erosion impact is pictured in Image (a), a bank with intermediate erosion impact is shown in Image (b), and a bank severely impacted by erosion is shown in Image (c).

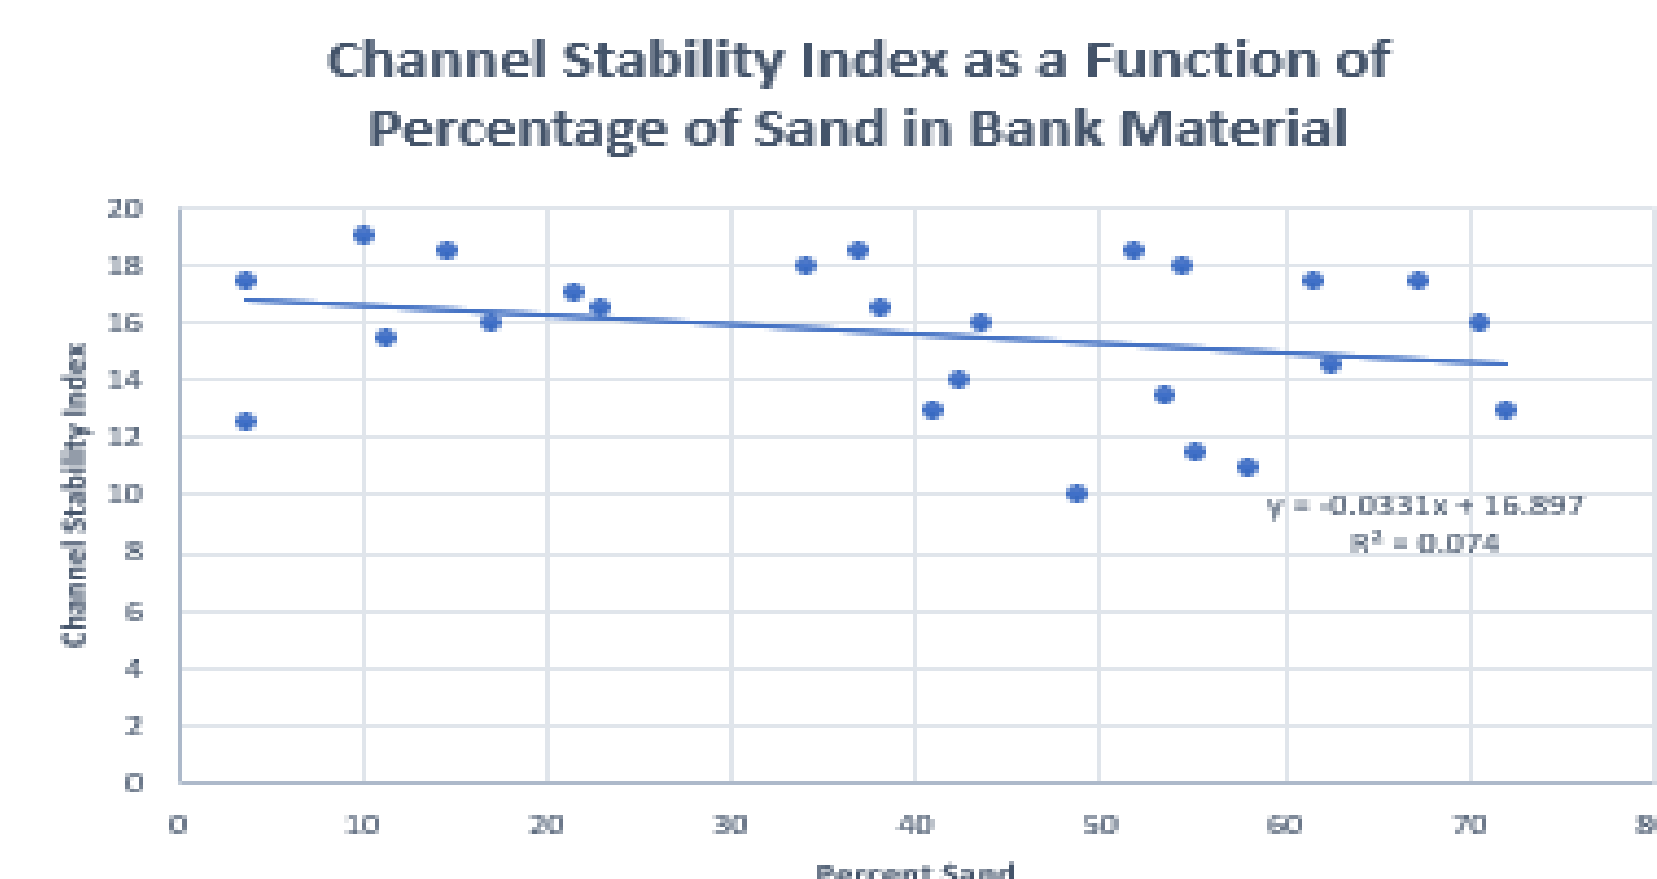
Figure 3: The CSI values are plotted against the percentage of sand in dominant bank material.

- When plotted against the Channel Stability Index (CSI), there was a trend with the channel factors (soil type and vegetation cover) with the CSI values. There was no trend identified for the percentage of sand plotted against the volume of bank erosion.
- There was a positive correlation between the vegetation cover and the CSI values, with a p-value of < 0.001 and correlation coefficient value of 0.6708 for the test.

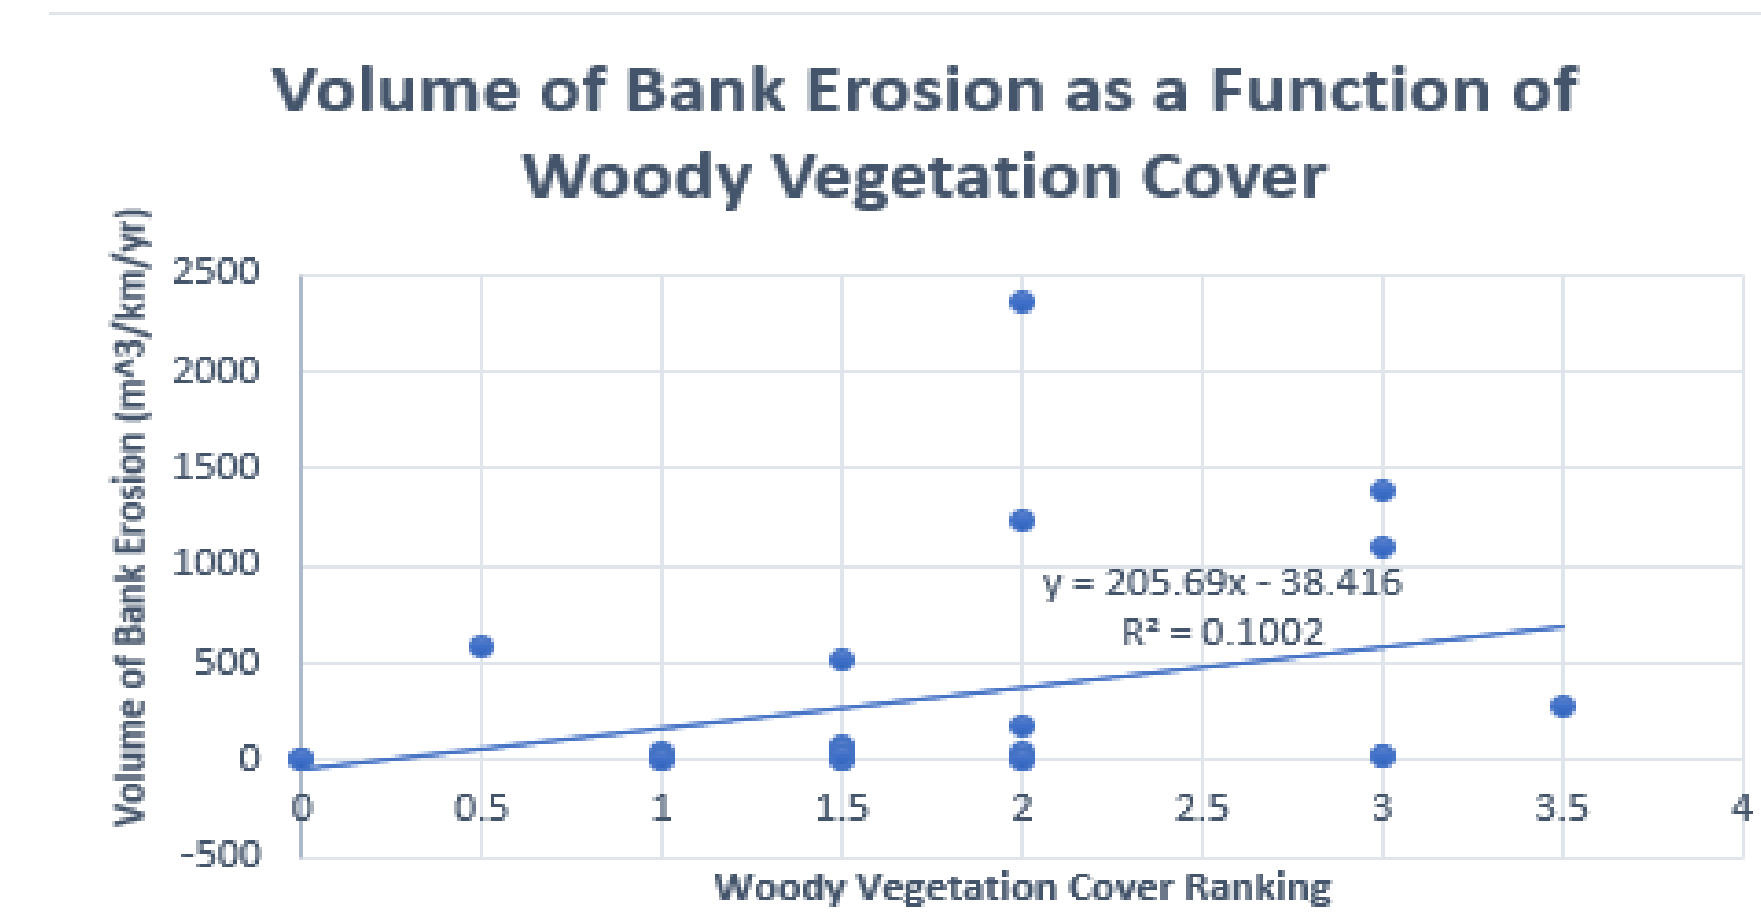
Figure 4: The volume of bank erosion measured by Simon et al. (2012) was plotted against the same vegetation cover ranking as shown in Figure 2.

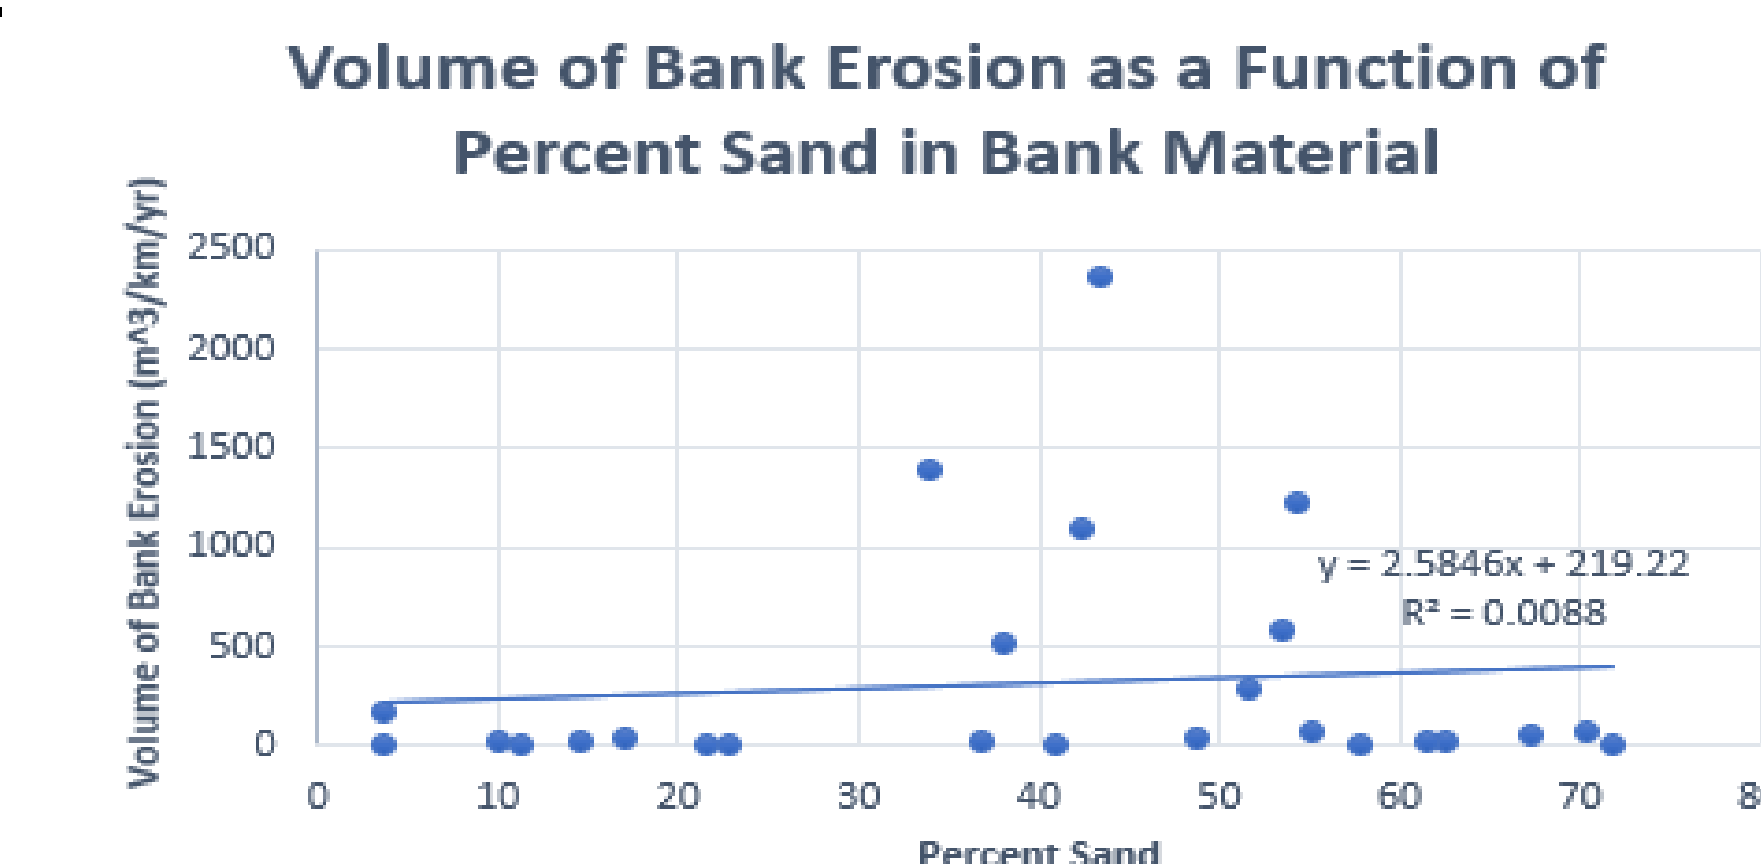
Figure 5: The volume of bank erosion measured was plotted against the same percent sand measurement as shown in Figure 3.
